Property Inspection Report

Brad Fischer 25022841
Solid Foundation Home Inspections

Sample Report — For demonstration purposes only
Inspection Prepared For: Client Name

Date of Inspection: 7/4/2025

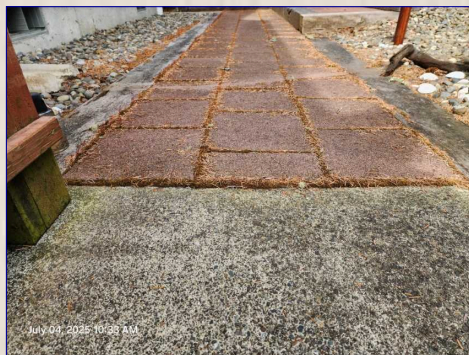
Uneven walkway slabs were observed, creating a potential trip hazard. Use caution in these areas. Recommend repair or replacement as needed by a qualified contractor.

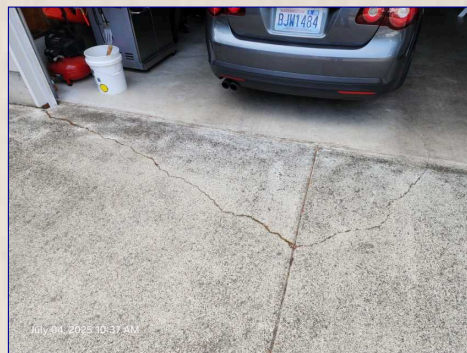
Page 7 Item: 2	Driveway/Parking	<ul style="list-style-type: none"> A crack extends from the driveway into the garage slab, which may indicate movement or settlement. Recommend monitoring and consulting a qualified contractor if movement continues or worsens.
----------------	------------------	---

- A crack extends from the driveway into the garage slab, which may indicate movement or settlement. Recommend monitoring and consulting a qualified contractor if movement continues or worsens.

A crack was observed extending from the driveway into the garage slab, which may indicate movement or settlement. Recommend monitoring and consulting a qualified contractor if movement continues or worsens.

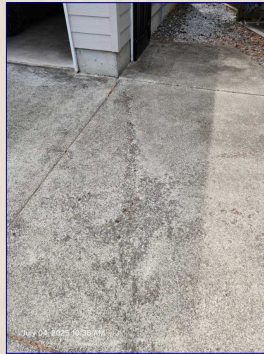
Areas of concrete spalling were observed at the driveway. Recommend repair by a qualified contractor as needed to help reduce further deterioration.

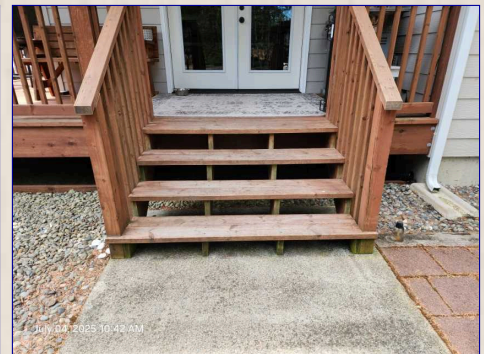
Page 8 Item: 3	Deck/Balcony	• Open risers were observed at the porch steps. This is a potential safety hazard. Recommend repair by a qualified contractor.
----------------	--------------	--

Open risers were observed at the porch steps. This is a potential safety hazard. Recommend repair by a qualified contractor.

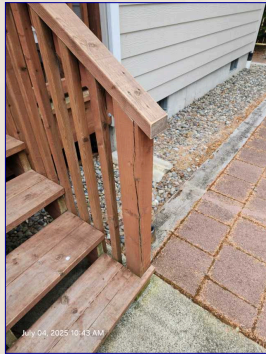
Typical checking/cracking was observed in porch wood components. Recommend sealing, painting, or treating exposed wood as needed to help reduce further deterioration.

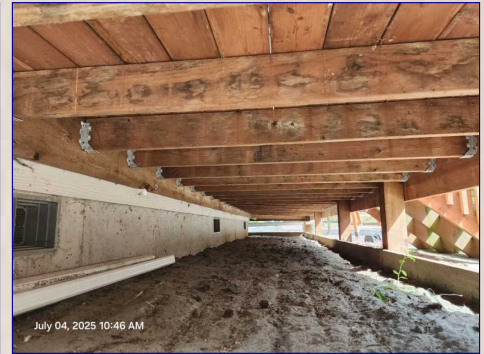
Organic growth was observed on wood components at the deck. Recommend treatment/removal and replacement of any damaged wood by a qualified deck contractor.

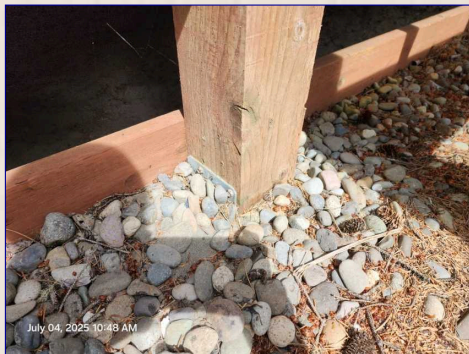
Soil/organic material was observed in contact with wood columns at the base. Recommend maintaining clearance between soil and wood to help reduce moisture damage and decay risk.

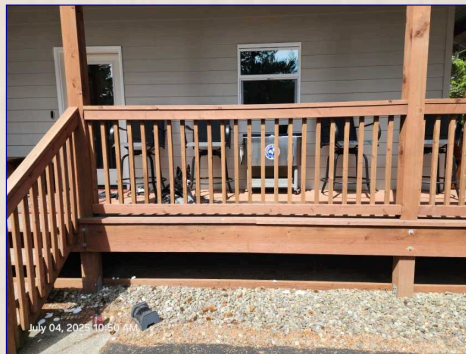
Guardrail posts appear to be spaced farther apart than typical current standards. Recommend evaluation and repair as needed by a qualified deck contractor.

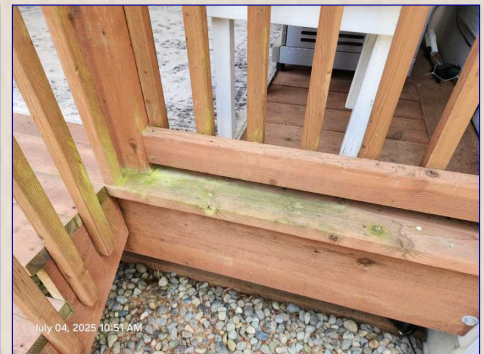
There is an organic type growth on the wood at the deck. Recommend a professional contractor treat/remove the growth and replace any damaged wood as needed.

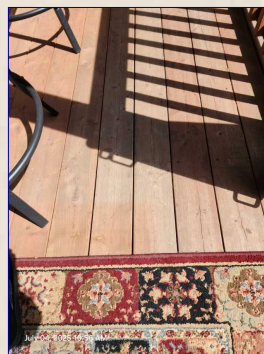
Deck wood needs painting, staining, or treatment to help protect it from moisture damage and deterioration.

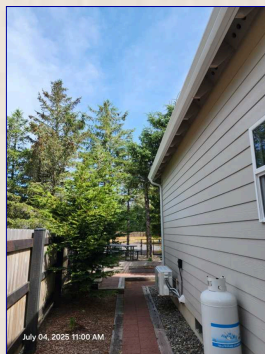
Large trees were observed near the house. No related damage was visible at the time of inspection. Recommend regular monitoring and consulting a qualified professional if movement, damage, or contact with the structure develops.

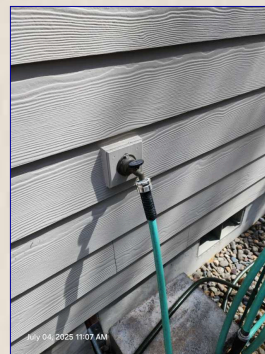
Hoses were attached to exterior hose bibs. During freezing weather, attached hoses can increase the risk of frozen or damaged pipes. Recommend removing hoses during freezing conditions.

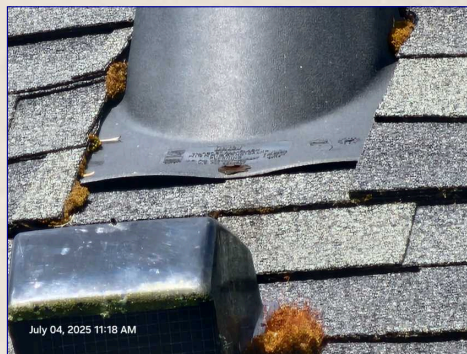
Exposed nail heads were observed at roof flashing. Exposed fasteners can allow water intrusion. Recommend sealing/repair by a licensed roofing contractor.

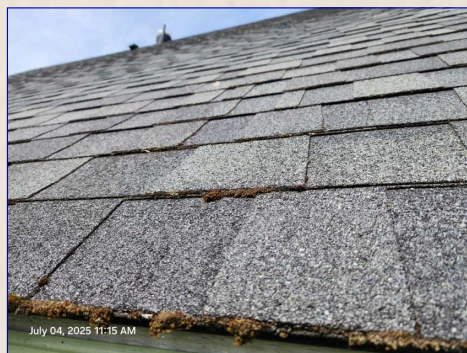
The shingles have moss buildup at the edges. Recommend cleaning and treatment by a qualified professional.

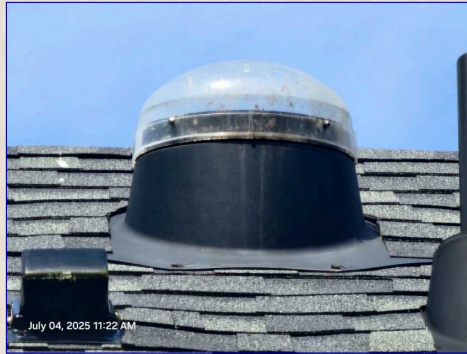
Page 14 Item: 6	Skylights	<ul style="list-style-type: none"> Exposed fasteners were observed at roof and skylight flashing. Exposed fasteners can allow water intrusion. Recommend sealing/repair by a licensed roofing contractor.
-----------------	-----------	--

Exposed nails were observed at the skylight flashing. Recommend sealing/repair by a licensed roofing contractor.

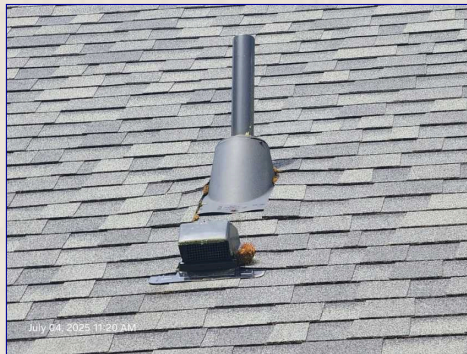
Moss buildup was observed at one or more roof vents, which can contribute to moisture retention and potential water intrusion. Recommend cleaning and treatment by a qualified professional.

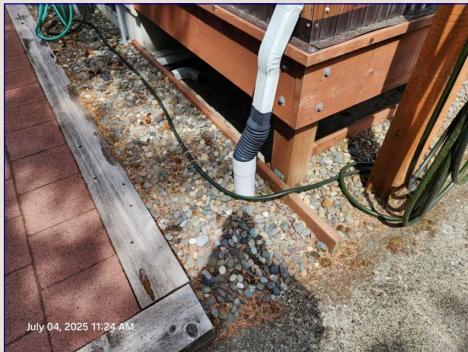
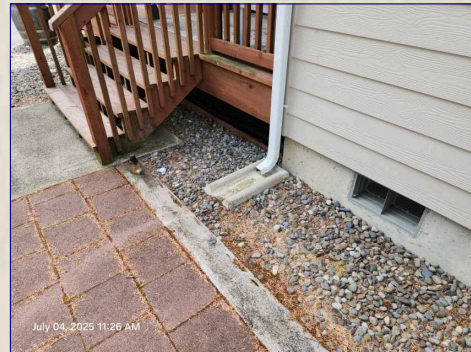
One or more downspouts terminate underground. The adequacy and final discharge location of the drainage system could not be determined.

The gutter downspouts do not direct water far enough away from the house. Recommend adding downspout extensions to discharge water away from the foundation.

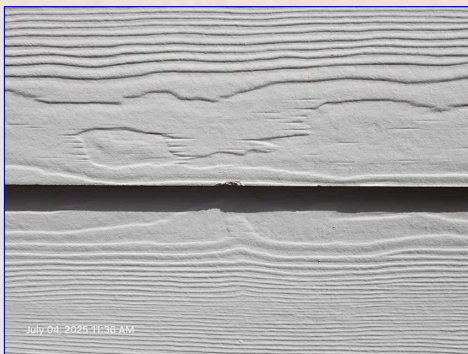
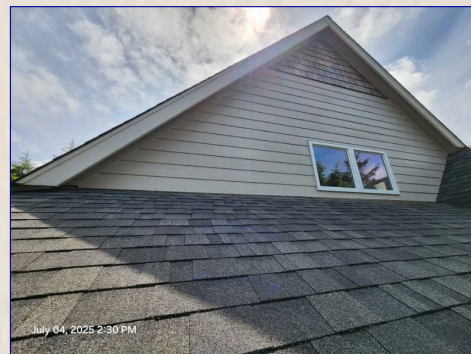
Page 15 Item: 2	Siding	<ul style="list-style-type: none"> Siding was observed close to or in contact with the roof surface. This can increase the risk of moisture damage. Recommend correction by a qualified contractor.
-----------------	--------	--

One or more areas of minor siding damage were observed. Recommend touch-up paint or repair as needed.

Siding was observed close to or in contact with the roof surface. This can increase the risk of moisture damage. Recommend correction by a qualified contractor.

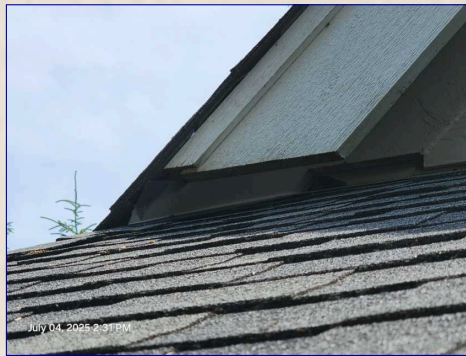
The fascia needs routine painting/maintenance. Recommend repair and painting by a qualified professional as needed.

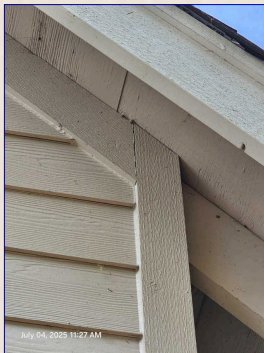
Exterior caulking was dried and cracked. Recommend removing and replacing failed caulking by a qualified contractor.

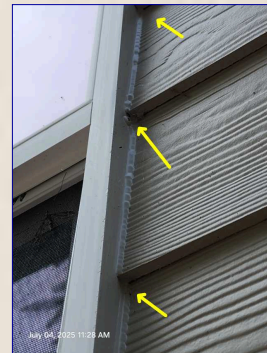
Recommend sealing around windows, doors, corners, and utility penetrations as needed to help reduce moisture and pest intrusion.

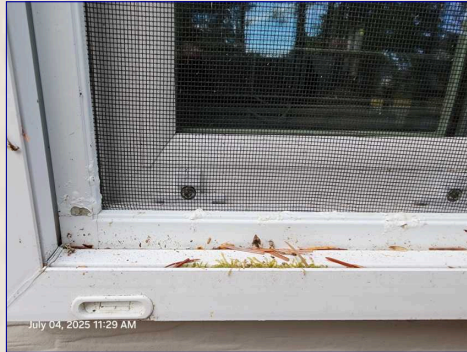
Window screens are outside the scope of the home inspection standards. As a courtesy, some screens were noted as torn, damaged, or missing. Repair as desired.

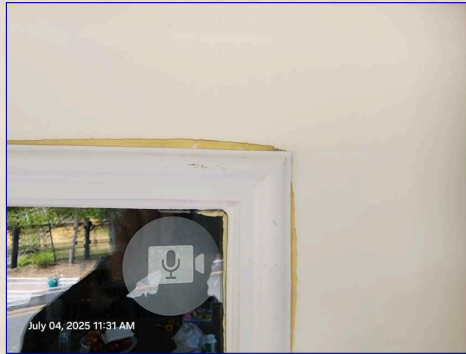
The weather seal around Door One's window glazing is pulling away from the window.
Recommend monitoring and consulting a qualified contractor for repair as needed.

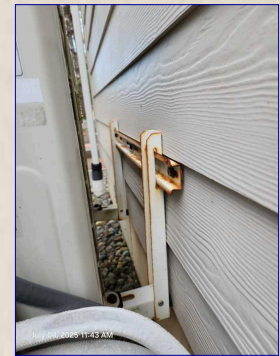
Page 18 Item: 1	Exterior A/C or Heat Pump	• Excessive rust/corrosion was observed at the heat pump outdoor unit. Recommend evaluation by a qualified HVAC contractor and budgeting for repair or replacement as needed.
-----------------	---------------------------	---

Excessive rust/corrosion was observed at the heat pump outdoor unit. Recommend evaluation by a qualified HVAC contractor and budgeting for repair or replacement as needed.

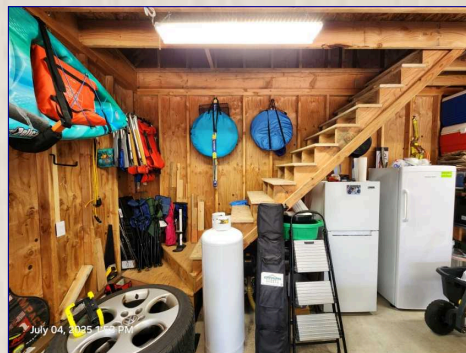
Page 19 Item: 1	Type	• Garage stairs have open risers and are missing a handrail. The second-floor area is also missing a guardrail. This is a safety hazard. Recommend repair by a qualified contractor.
-----------------	------	--

Garage stairs have open risers and are missing a handrail. The second-floor area is also missing a guardrail. This is a safety hazard. Recommend repair by a qualified contractor.

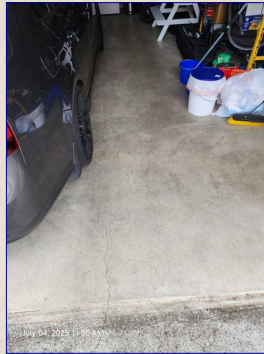
Page 20 Item: 8	Floor	<ul style="list-style-type: none"> Large cracks were observed in the garage floor slab. Recommend further evaluation by a qualified contractor.
-----------------	-------	--

Large cracks were observed in the garage floor slab. Recommend further evaluation by a qualified contractor.

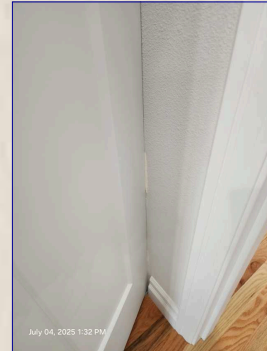
One or more doors are rubbing during operation.
Recommend monitoring and consulting a professional contractor as needed.

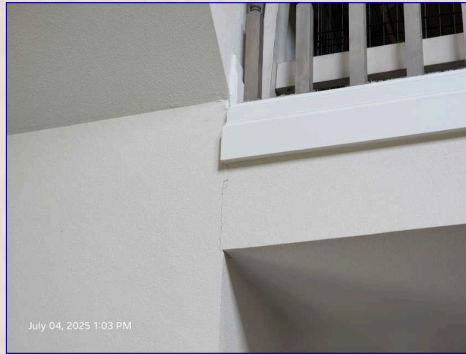
Typical minor cracks were observed at walls/ceilings. Monitor and repair as needed.

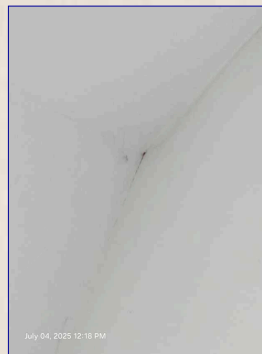
There are typical cracks on the walls/ceilings. Monitor and repair as needed.

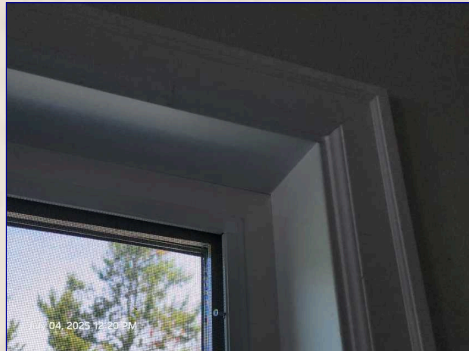
Caulking/sealant is needed around the window. Recommend repair by a qualified contractor.

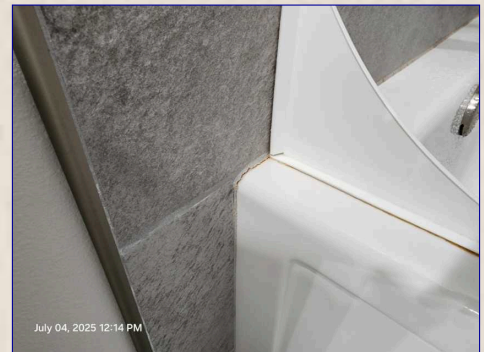
Recommend repairing or replacing deteriorated caulk/grout at the shower/tub area to help reduce the risk of water damage.

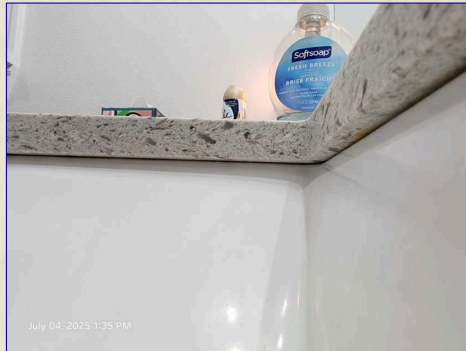
Caulking was missing at one or more sinks. Recommend repair as needed by a qualified professional.

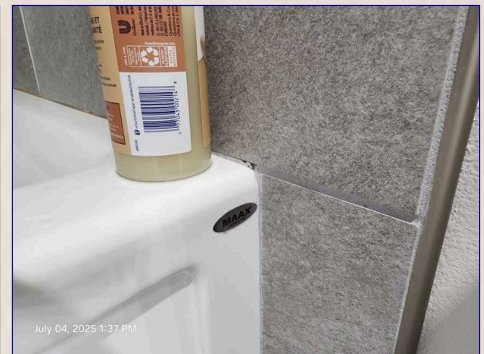
Recommend caulking/grouting in the shower and tub area to help prevent damage from water penetration.

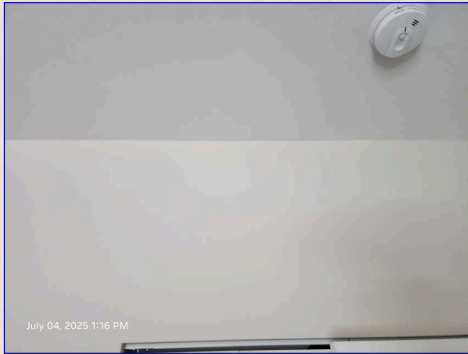
Typical minor cracks were observed at walls/ceilings. Consult a qualified contractor for repair as needed.

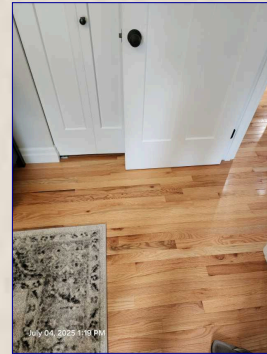
Page 35 Item: 2	Walls/Ceiling/Floor	<ul style="list-style-type: none"> The floor slopes toward the wall. Recommend evaluation and repair as needed by a qualified contractor.
-----------------	---------------------	--

The floor slopes toward the wall. Recommend evaluation and repair as needed by a qualified contractor.

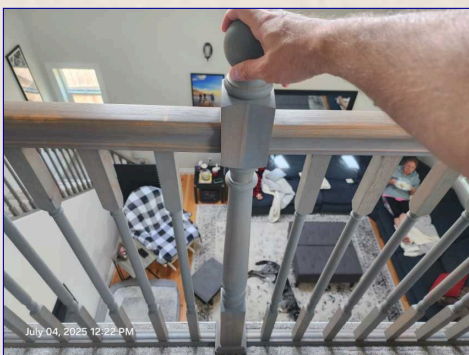
Page 37 Item: 1	Stairs, Steps, Hallways	• The handrail to the second floor is loose, which is a potential safety hazard. Recommend securing/repair by a qualified contractor.
-----------------	-------------------------	---

The handrail to the second floor is loose, which is a potential safety hazard. Recommend securing/repair by a qualified contractor.
