Property Inspection Report

Brad Fischer 25022841
Solid Foundation Home Inspections

Sample Report — For demonstration purposes only
Inspection Prepared For: Client Name

Date of Inspection: 7/4/2025

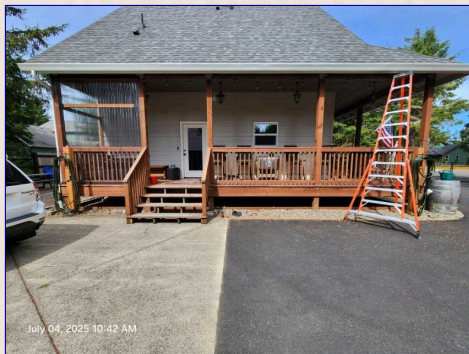
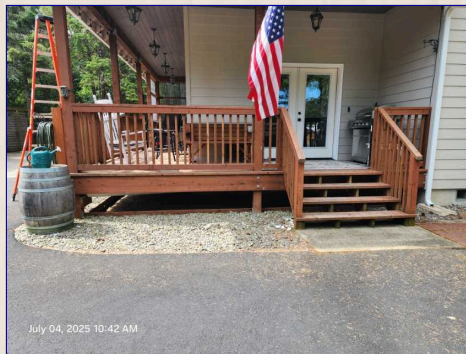
- Wood in contact with soil
- Safety hazard
- Deck ledger flashing installed: Yes

- Organic growth, wood-to-soil contact, and maintenance needs were observed at deck/porch components. Recommend treatment/removal, maintaining clearance at wood components, and replacement of damaged wood as needed by a qualified deck contractor.
- Open risers were observed at the porch steps. This is a potential safety hazard. Recommend repair by a qualified contractor.

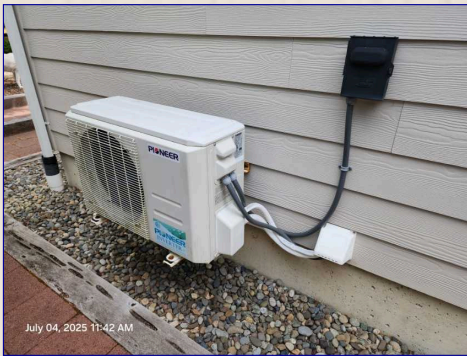
• Excessive rust/corrosion was observed at the heat pump outdoor unit. Recommend evaluation by a qualified HVAC contractor and budgeting for repair or replacement as needed.

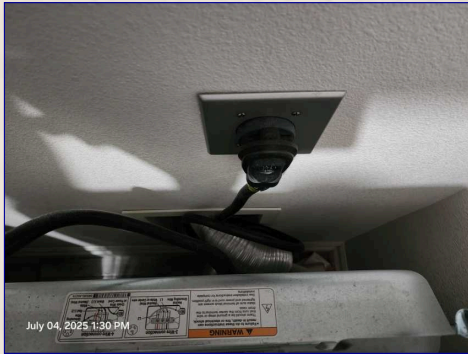
The dryer hook-up view

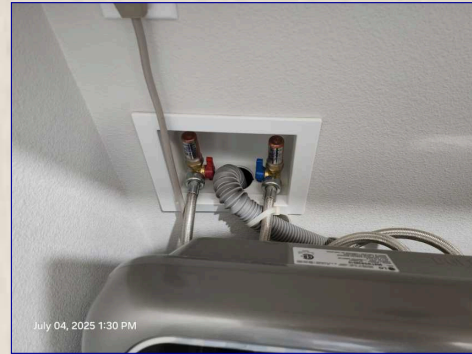
Laundry, washer hook-up view

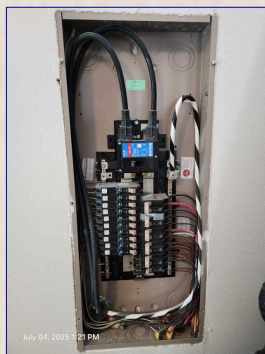
The main electrical service panel
