Property Inspection Report

Brad Fischer 25022841
Solid Foundation Home Inspections

Sample Report — For demonstration purposes only
Inspection Prepared For: Client Name

Date of Inspection: 7/4/2025

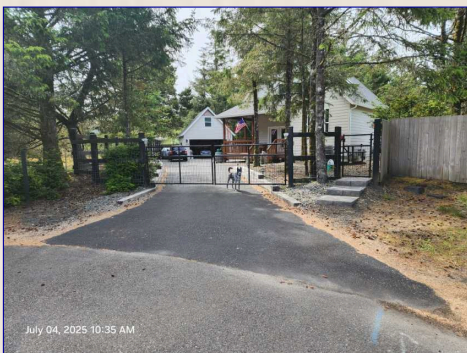
- Settling cracks

- A crack extends from the driveway into the garage slab, which may indicate movement or settlement. Recommend monitoring and consulting a qualified contractor if movement continues or worsens.

A crack was observed extending from the driveway into the garage slab, which may indicate movement or settlement. Recommend monitoring and consulting a qualified contractor if movement continues or worsens.

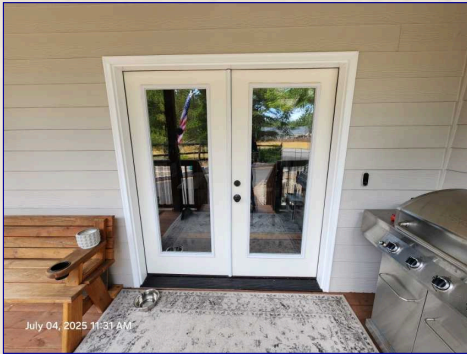
Door One

The weather seal around Door One's window glazing is pulling away from the window.
Recommend monitoring and consulting a qualified contractor for repair as needed.

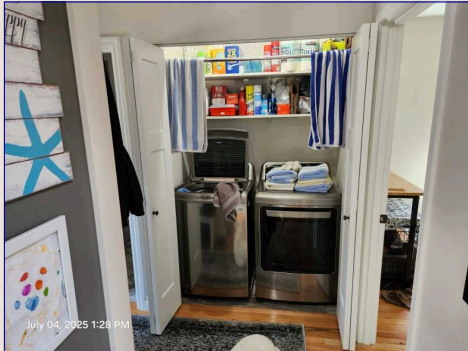
The Laundry Room View

One or more doors are rubbing during operation.
Recommend monitoring and consulting a professional contractor as needed.

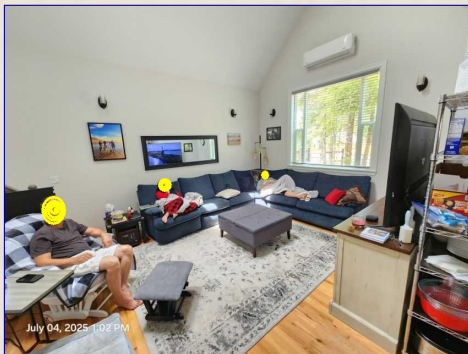
The Living Room View

Typical minor cracks were observed at walls/ceilings. Monitor and repair as needed.

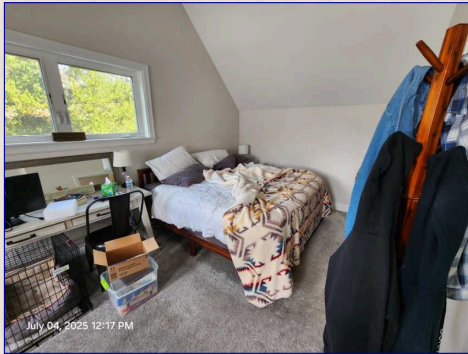
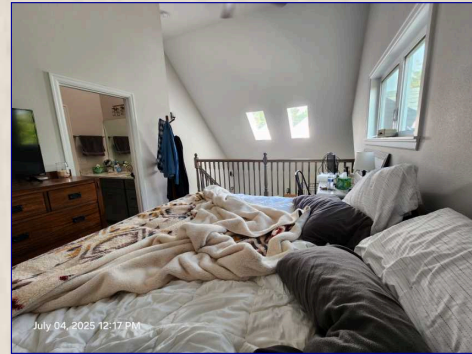
The Loft View

There are typical cracks on the walls/ceilings. Monitor and repair as needed.

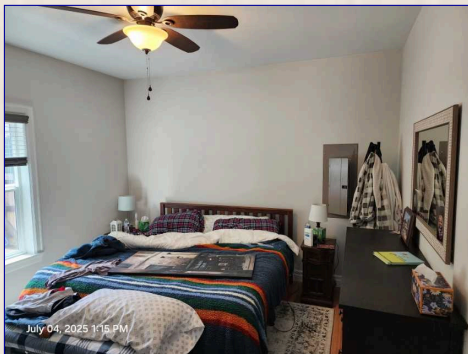
The Bedroom View

- The floor slopes toward the wall. Recommend evaluation and repair as needed by a qualified contractor.

Typical minor cracks were observed at walls/ceilings. Consult a qualified contractor for repair as needed.

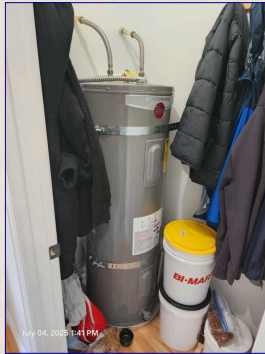
The Water Heater Area
